# Early Implantation with oval, not rotating Implant ROSI™

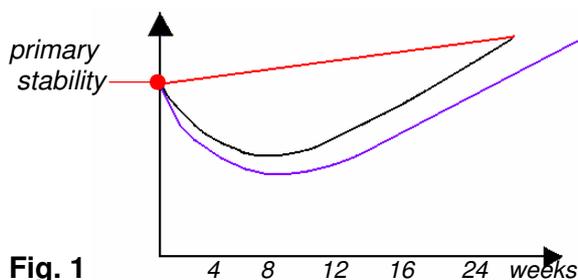
Fig. 1

*Development of stability in oval, not rotating implant without thread (ROSI®).*

*Development of stability with a continuous screw thread.*

*Development of stability screw threads only in the spongy bone.*

According to *S. Raghavendra et al. 2005* most implant failures occur in the critical early healing between the second and fourth week. Here is seen a gap of stability according to *Raghavendra* by a decrease in the primary stability and the slow increase of secondary stability in the end of the healing process.

As for ROSI® implants apparently there is no decrease to realize at this time, much-more, the stability increases slowly compared to the initial stability since insertion. Mastication was possible immediately after cementation of the crown.

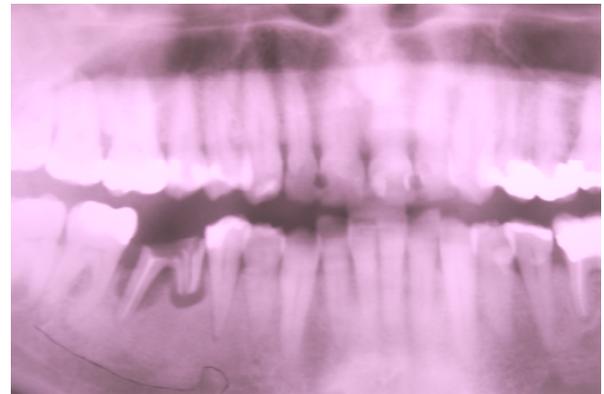
Fig. 2

61-year-old male patient, smoker.  
broken tooth 46 (Fig. 2).

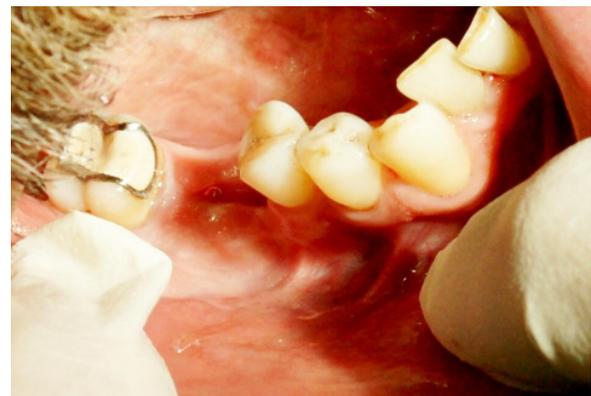
Fig. 3

State two weeks after extraction of tooth 46 (Fig. 3).

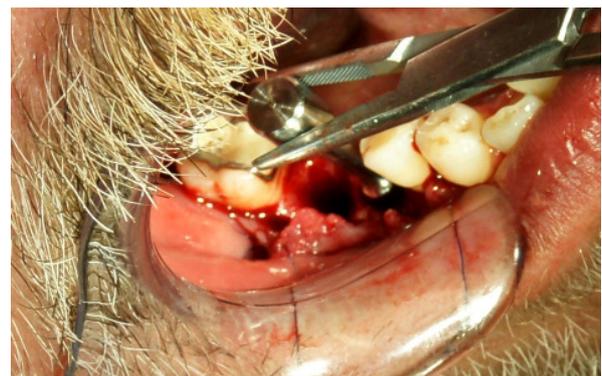
Fig. 4

Flap and stepwise cylindrical bore in both alveoli up to 4 mm diameter. Applying the probe for determining the tilt of 1.5 mm with 3,5 mm drill non cutting (blunt) tip (Fig. 4) for receiving the 13 mm long oval implants.

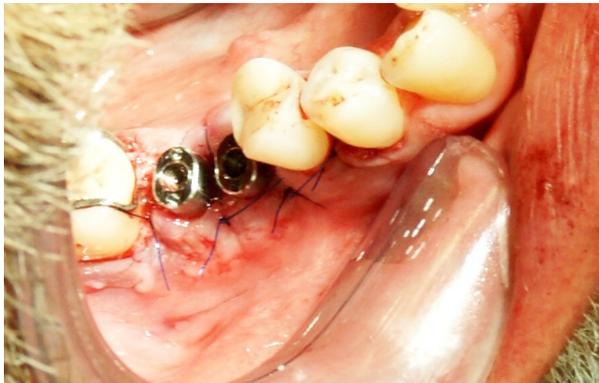
**Fig. 5**

The oval, not rotating implants ROSI™ were inserted together with healing post, pressed with fingers into the cavity and fixed with light hammer blow. Subsequently, the gingiva was adapted with a thin atraumatic suture (Fig. 5).

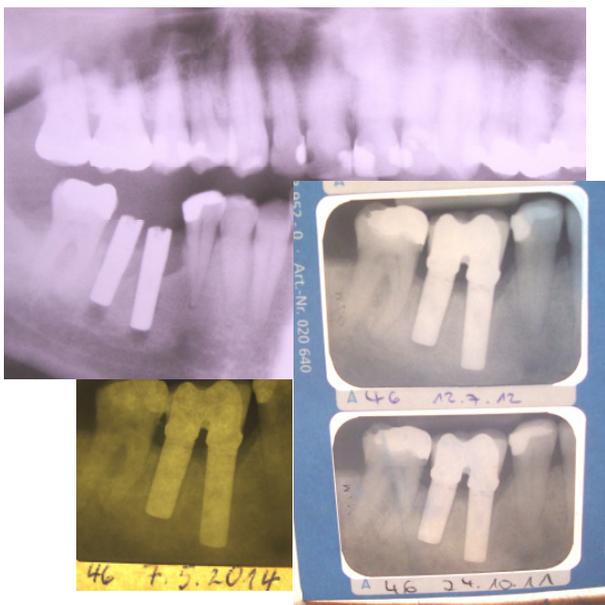
**Fig. 6**

Fig. 6 shows x-ray, state after insertion of the two 13 mm long, not rotationally symmetric ROSI® - implants with attached healing post, height 5mm.

Measurement with Resonance Frequency Analysis (RFA) with Periotest® (Medizin-technik Gulden) immediately after insertion of implants shows for both implants +1. Periotest® values between -8 and +9 correspond to a measurement with fingers degree 0. The following measurements after 1, 2. and 3 weeks were also with fingers degree 0.

There always was clear sound, which suggests a high stability. The Periotest® - values were +0.9 and +1.7 after 3 weeks.

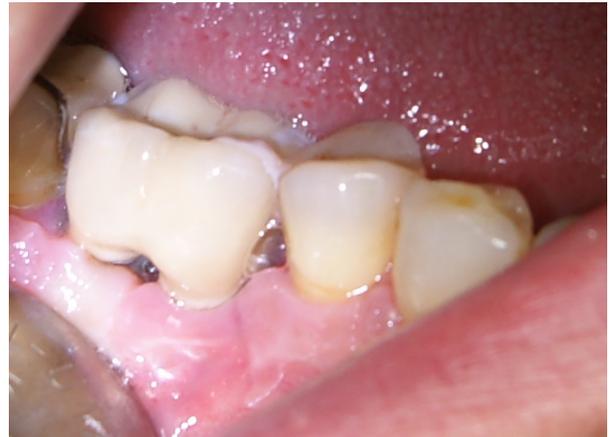
**Fig. 7**

Four weeks after implantation a Zr-crown was cementated (Fig. 7). Without crown the Periotest® values were distal root 0.0 and mesial -2.6 and, well above the primary stability at insertion.

The RFA measurement with Periotest® after inserting the Crown was -4.5. This is a value which is well above the average values of lower molars.
